DEPARTMENT OF NATURAL RESOURCES Division of Oil, Gas & Mining

Inspection Report Minerals Regulatory Program

Mine Name: Asphalt Ridge	Permit number: M/047/022			
Operator or Permittee Name:	Inspecti	on Date: O	ctober 26, 200	4
Uintah County	-			
Permittee Mailing Address:				
1489 E. 335 S., Vernal, UT 84078				
	Weather	: Partly clo	udy, 50's	
Inspector(s): Paul Baker	Inspection Start Time: 10:30 AM			
	Inspecti	on End Tin	ne: 12:30 PM	
Other Participants: Paul Feltch, two other count	ty Site loca	tion/Area I	nspected (i.e.	Pit #):
employees, and Kim McDonald			on of the area	,
Permit Status: Active	Surface Ownership: SITLA and Fee			
Current Acreages:	Mineral	Ownership	: Fee	
Total Permitted (Bonded): 44	Mineral	Mined: Tai	r Sand	
Total Disturbed: 44	Type of	Mine: Surfa	ace	
Elements of Inspection	Evaluated	N/A	Comment	Enforcement

M/037/022, Asphalt Ridge Mine, Uintah County

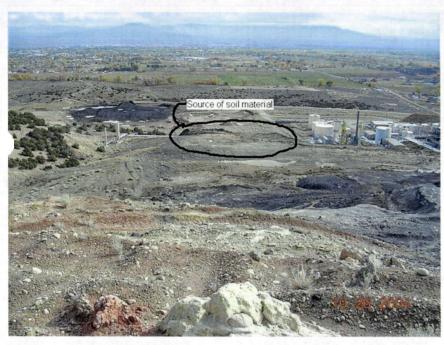
Photo 1. The circled area contains material that was apparently graded down from areas closer to the foreground.

Most of our discussion focused on backfilling and grading. The primary concern was regrading of the area shown across the middle of Photo 2. The area should be smoothed to a more natural contour, but rock outcrops do not need to be graded. The surface should then be ripped prior to applying soil. Soil would be brought in scrapers from the area circled in Photo 1 and applied at a thickness of about one foot.

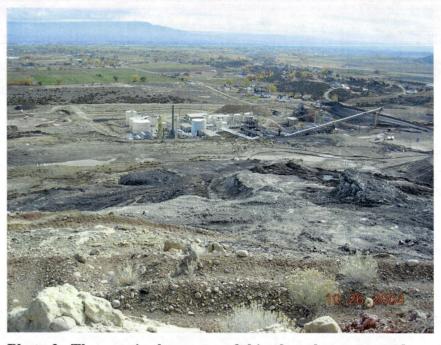
The area in the foreground of Photo 2—the area where we were standing as we discussed some of the grading—has some loose material but is probably underlain by bedrock. It should be possible to grade some of this material down over a dug road that leads up the hill, and to generally shape this area to blend with the surrounding topography. The soil in this area appeared to be clayey, so it might be desirable to cover it with a few inches of a better soil.

Photo 2. The area in the center of this photo has some rock outcrops, but, as far as possible, it needs to be graded to blend with surrounding topography.

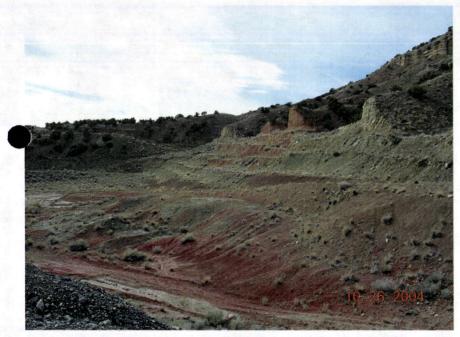
The material in the center of Photo 3 will need to be graded to a more moderate slope—especially on the south side—and to make it blend with nearby areas. Soil could then be brought by scrapers to cover this material so it could be revegetated. To the west, there is a drainage in the undisturbed area, and I marked an area in Photo 3 where this drainage would naturally come across the disturbed area. The operator should keep this as a channel, and we discussed putting large rocks and possibly some drop structures in this channel.

Photo 3. The area near the center of this photo is a highwall that was reclaimed several years ago. No grading should be needed in this area.

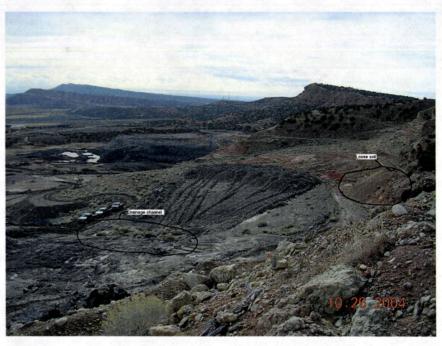
We talked about the stepped highwall shown in Photo 4 and decided it could remain as it is. Just to the north of this highwall is an area with what appears to be some fairly loose soil (circled in Photo 3). It appears this material could be graded down the slope to make it more stable and suitable for revegetation.

Photo 4. Marked are areas where a channel could be placed (left) and where some loose material could be graded to make a more stable slope.
